## ANALYSIS OF PRACTICAL GROUND CONTROL ISSUES IN HIGHWALL MINING

### ABSTRACT

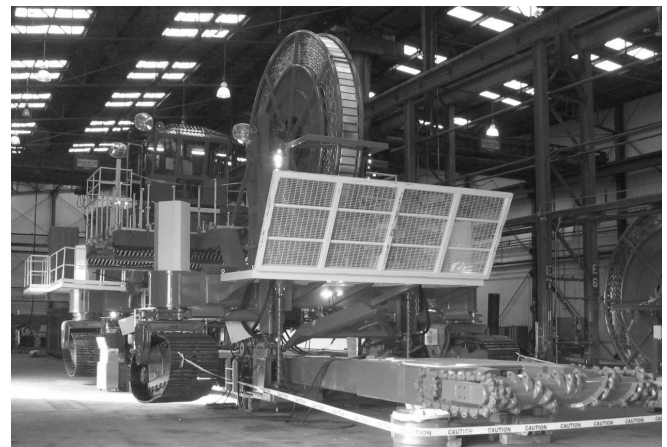
Figure 1. Superior Highwall Miner under construction. Note thin seam cutter-head, control cab and cable reel.

The Superior Highwall Miner Company (5, 6, 10) manufactures the SHM<sup>1</sup> shown in figure 1. In its present design, the miner head is a modified Joy Mining Machinery miner that feeds a series of 20-foot-long pushbeams containing counter-rotating augers for coal transport. Maximum penetration depth is approximately 1,000 feet.

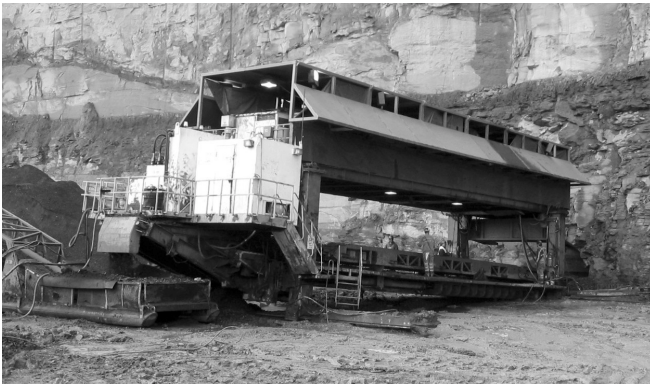
Figure 2. Addcar Highwall Miner in operation. Note: Addcar in launch vehicle, control cab and discharge conveyor.

Mining Technologies Inc. (MTI) (1, 2, 5, 8, 9, 11) builds the Addcar highwall miner system shown in figure 2. MTI developed its own highwall miner heads that are similar to conventional continuous miners. The miner head discharges onto a series of 40-foot-long cascading conveyor sections known as the Addcars. Penetrations up to 1,600 feet have been achieved. Addcar systems are equipped with cameras that allow the operator to view face conditions, and the latest models feature a gyroscopic guidance system (HORTA) for improved navigational control.

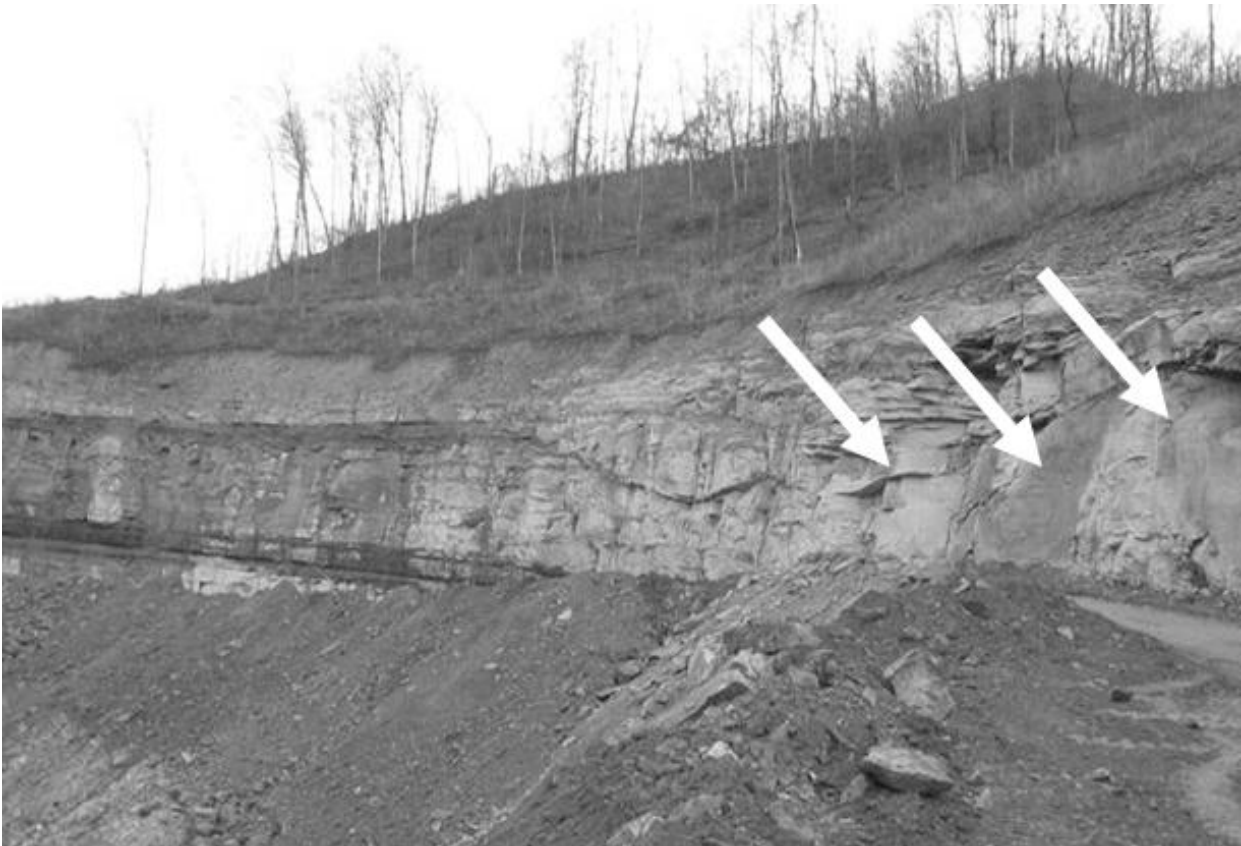
Figure 8. Web pillar failure occurred along highwall to the right. Note that several large rock wedges were dislodged as indicated by arrows. Undamaged highwall is to the left.

The second concern related to highwall ground control is the stability of web and barrier pillars (4, 13, 14, 16, 17). Figure 7 shows a typical set of highwall mining holes, the web pillar in between holes and a barrier pillar (skip block or skip hole) left between panels. Proper ground control engineering is required for sizing the web and barrier pillars for stability. Layout of these pillars has a profound effect on coal recovery and the project economics; however, equally important is its effect on highwall stability from a safety standpoint. Adequate stability of the web and barrier pillars, especially at shallow depth near the surface, is essential for highwall stability. Web pillar failure and the subsequent subsidence of the overlying rock can destabilize the highwall face. Figure 8 shows an area where web pillar failure led

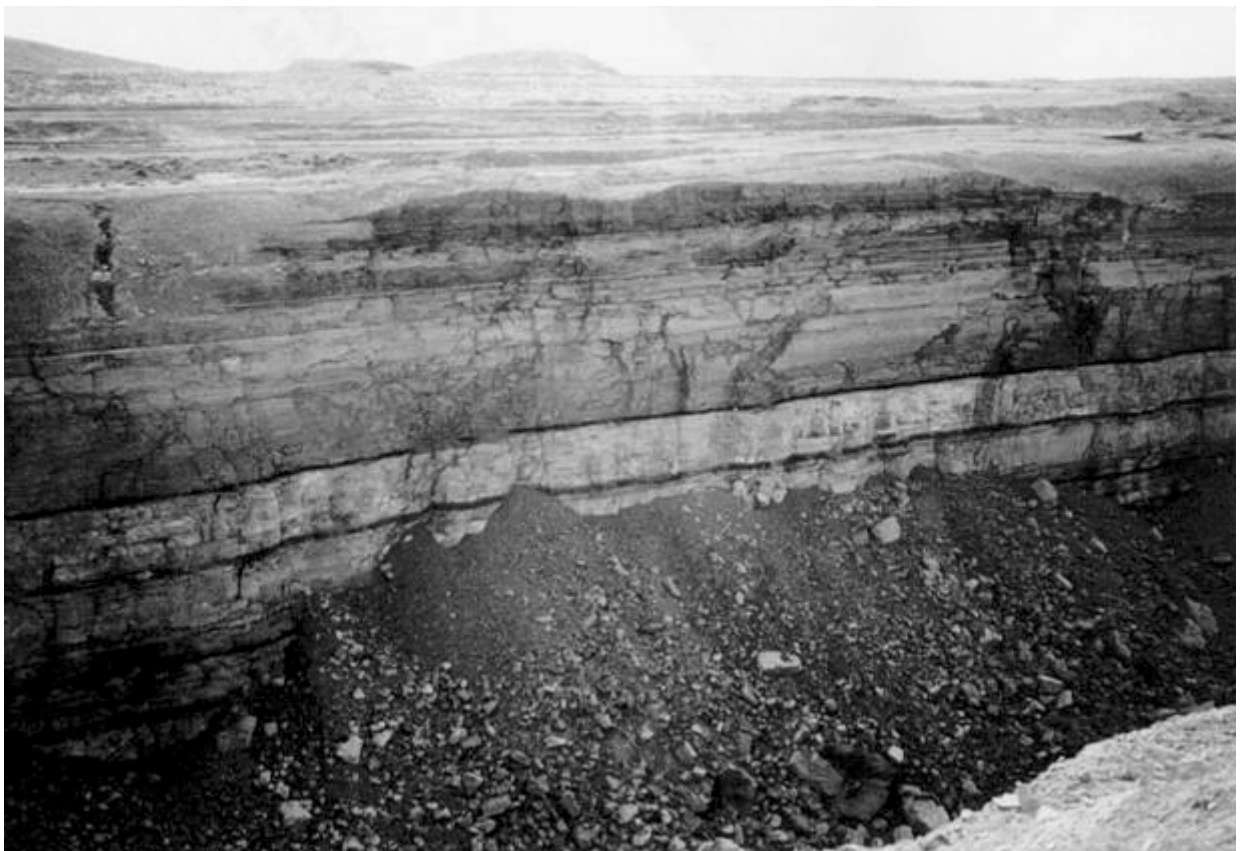
Figure 9. Site of massive web pillar collapse resulting in highwall slope failure. Photograph is taken from adjacent spoil pile. Highwall is about 150 feet high. A 110 ton coal haulage truck is buried in rockfall debris.

to large rock falls from the highwall. Figure 9 shows an even more spectacular failure (16). In this case, 30 to 50 web pillars failed suddenly, which caused substantial rock fall from the highwall. The rock fall was sufficient to completely bury a 110 ton coal haulage truck. Fortunately no one was in the pit when this failure occurred.
